Appendix F: Aquifer Recharge Soils Report

MEMORANDUM

DATE: December 11, 2006 Job/Project Number: 75739
TO: Mr. Doug Connelly and Mr. Doug Campbell
FROM: Jim Bailey

SUBJ: East Maple Ridge Subdivision Soil Infiltration Evaluation

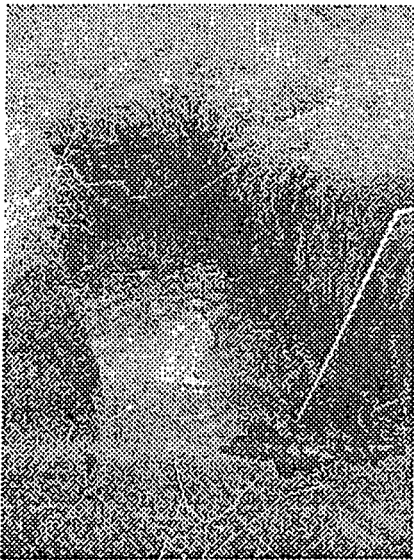
Figure 3 – Perched Ground Water TP-8B

Ground water was observed seeping into all of the test pits on the south side of the site including TP-8A, TP-B, TP-C, and TP-10A. The seepage was occurring in the courser segments of the recessional outwash deposits and rapidly filled the test pit with two to three feet of water within an hour (see Figure 3). No perched water was observed in the remaining test pits.

Based on the soil conditions and the results of the test pit excavations, the ground at the site does not have a sufficient thickness of unsaturated soil above the water table or the low permeability glacial till to be a candidate for direct storm water infiltration. Our interpretation of the soil conditions observed in the test pits indicate that for any reasonable set of assumptions the groundwater inflow rates beneath an infiltration pond would form a ground water mound which would eventually rise up into the pond preventing further infiltration.
